Replacing the RF input amplifier (TQP3M9008)

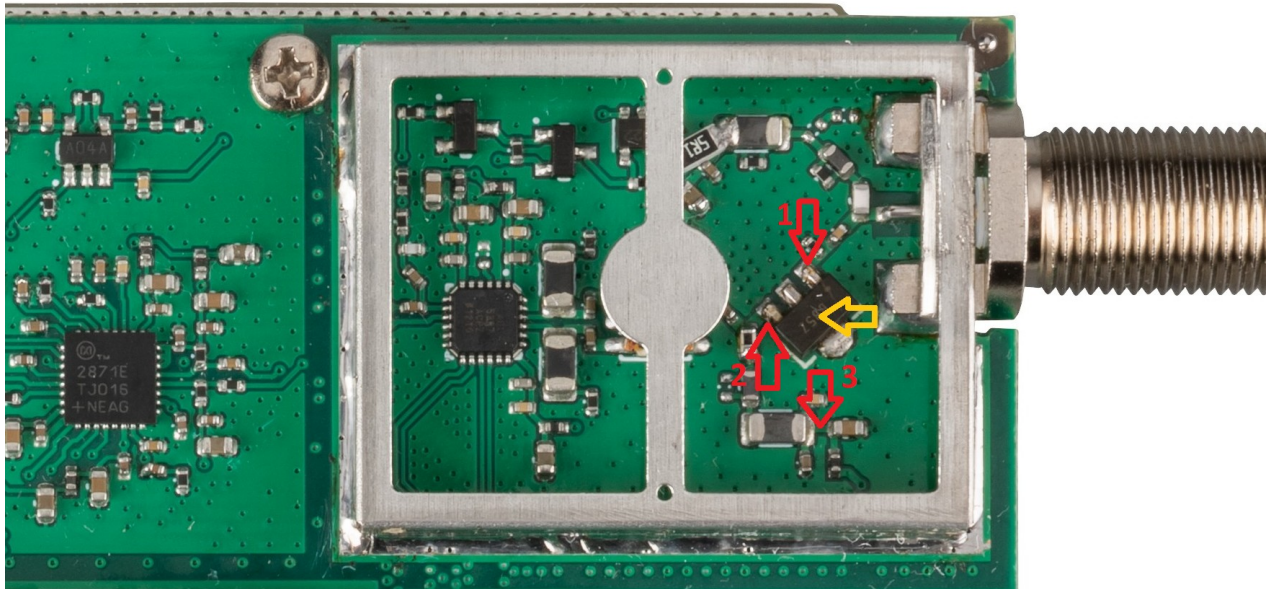
If the amplifier fails due to electrostatic induction, a sharp decrease in the sensitivity of the radio receiver occurs. To restore its performance, it must be replaced.

To confirm the diagnosis, you should measure the voltage (with the receiver turned on) between the ground and arrow 1, the working range is 0.45-0.65V. And the voltage between arrows 2 and 3 is a working range of 0.1-0.2V. If at least one of them is out of range, then the amplifier should be replaced (be sure to turn off the receiver!). The location of the amplifier is indicated by a yellow arrow. It is advisable to replace it with a hot air gun.

To do this, unscrew the side covers of the receiver without unscrewing the RF connector nut. Then carefully remove the shielding cover located next to the input connector.
